**3434 Humboldt Street**

## LBP Assessment Results

## Strata Environmental Resource

# Property ID # 264 / 3434 Humboldt Street

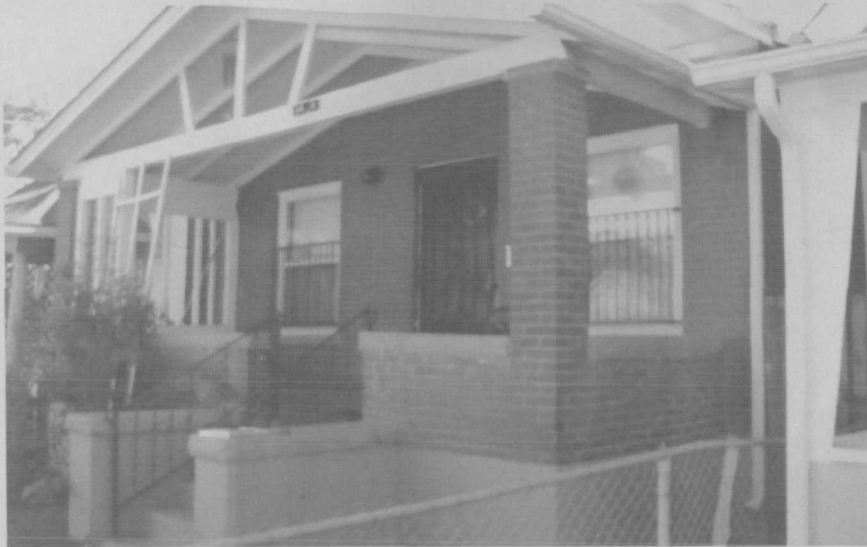
West exposure of house

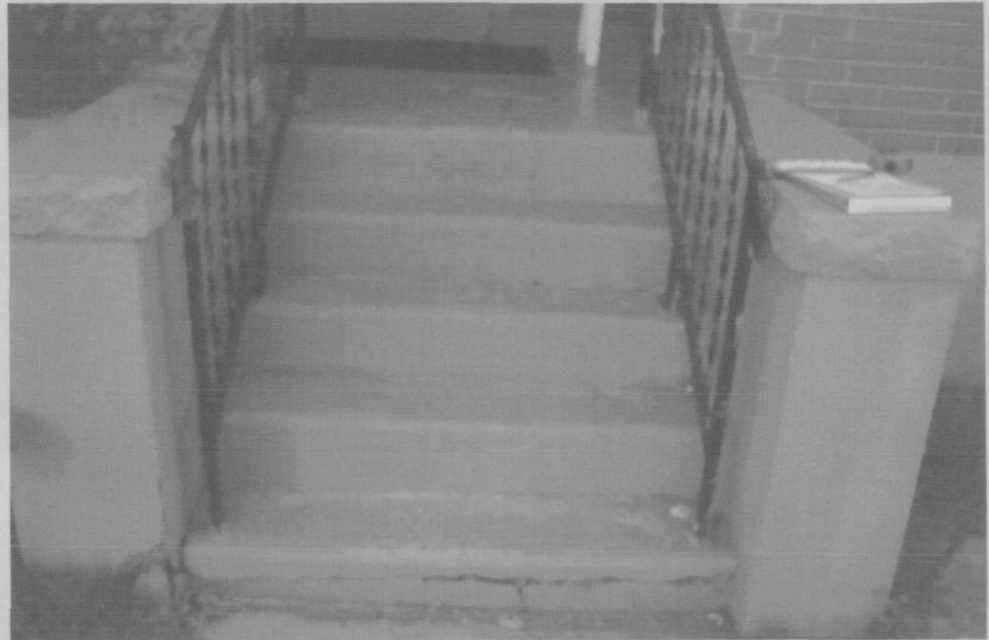
Window Trim/Fascia/Soffit				Patios/Decks/Porches			
Material	Area	Peel/Chip	XRF (Lead)	Material	Area	Peel/Chip	XRF (Lead)
North				BRICK FOUNDATION	—	—	3.0
South				WOOD HEADERS	—	—	3.1
East				WOOD CEILING	—	—	2.4
West				CEMENT	24'7"	PEEL	8.5

West cement stairs contain peeling lead paint
